Aviation Maintenance Alerts

AC No. 43-16A

**ALERT NO. 255
OCTOBER 1999**

**Improve Reliability-
Interchange Service
Experience**

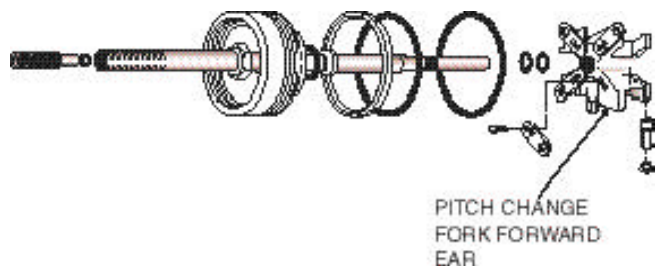
Beech; Models 1900; Propeller Pitch-Change Fork Cracks; ATA 6120

Several similar reports concerning cracking of the propeller pitch-change fork prompted this article. Also, this defect was found on two Beech B200 aircraft which had a four-bladed propeller installed in accordance with Supplemental Type Certificate (STC) SA2698NM.

The propeller installed on these aircraft was a Hartzell HC-X4 series and used the same pitch-change fork (P/N 57D0495). All of the cracks occurred in the inboard radius of the pitch pin engagement slot of the forward ear of the pitch-change fork. (Refer to the following illustration.) The FAA Service Difficulty Program data base contains 55 entries of similar defects. Multiple cracks were noted on most of the reports. This problem may not be specific to the aircraft mentioned here. Cracks may occur with any installation using this pitch-change fork. Frequent and thorough inspections of the pitch-change forks should be accomplished until this problem is resolved.

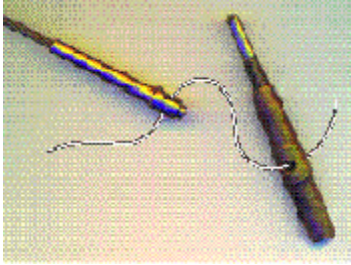
Cessna; Model 172H; Skyhawk; Defective Aileron Control System; ATA 2711

The technician removed the plastic covers behind the instrument panel and attempted to adjust the aileron cable tension. He discovered a broken turnbuckle terminal end. The aileron cable connection was maintained by a single strand of .041-inch safety wire, and the cable tension was loose. (Refer to the following illustration.) It appeared that the terminal end had been broken for some time, and the safety wire had stretched approximately .375 inch.

The submitter recommended thoroughly inspecting all flight control turnbuckles during scheduled inspections, and when the control yoke changes position to maintain level flight.

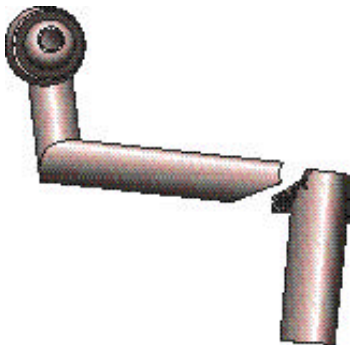
A followup investigation revealed that the right aileron traveled past the stop. The technician removed the belly pan to gain access to the flight control system and discovered the right aileron control link tube (P/N 730006-000) broken. (Refer to the following illustration.) The crack was located just outboard of the aileron bellcrank and adjacent to a weld.

The submitter stated he found this defect on several other like aircraft. The FAA issued Airworthiness Directive (AD) 98-24-11. The AD requires that these tubes be removed and inspected every 100 hours time in service until they are replaced with an updated aileron control link.

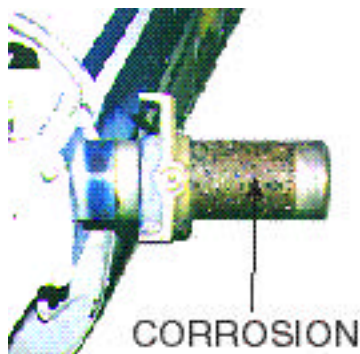
Piper; Model PA 24-250; Comanche; Stabilator Corrosion; ATA 5520

Both the left and right stabilators were very difficult to remove from the torque tube. The inboard fitting (P/N 21420-02) mount bolts were removed from the stabilators and left on the torque tube while the stabilators were removed. After disassembling the torque tube, the technician found severe corrosion. The corrosion products inhibited the removal of the fitting. The location of the stabilator torque tube makes proper inspection very difficult which may account for the condition found in this case. (Refer to the following illustration.)

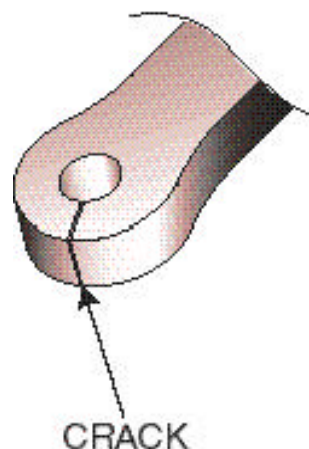
Piper; Model PA 30; Twin Comanche; Rudder Hinge Crack; ATA 2720

During the process of painting the aircraft, the painter stripped the paint from the vertical fin and discovered a crack in the upper rudder hinge.

The technician conducted an inspection and discovered more than one previously-accomplished major repair on this aircraft. (Refer to the following illustration.) The aircraft maintenance records did not document any of these repairs.

The submitter suggested that this crack was overlooked for some time because it was hidden by paint. Technicians should investigate suspicious areas, such as this, during scheduled inspections.

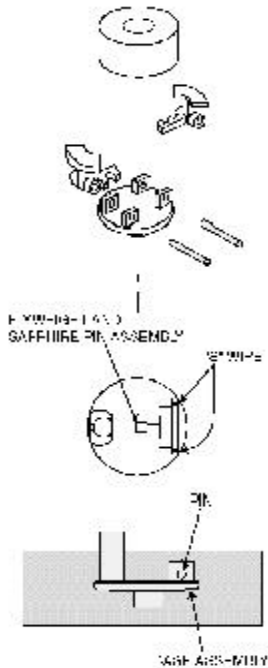
Bell; Model 204 and 205 Series; Power Turbine Governor Defect; ATA7320

While disassembling the PTG for overhaul, one of the two “S” safety wires was missing. The manufacturer’s technical data uses the term “S” wire to describe the safety device that secures the flyweight sapphire pin assemblies. (Refer to the following illustration.)

The “S” wire is installed through the hole at one end of the sapphire pin and then the pin is inserted through the prongs of both the flyweight assembly and the flyweight sapphire assembly. Once the pin is in place, an “S” wire is installed in the second, opposite pinhole. The missing “S” wire allowed the sapphire pin to migrate out far enough to contact the governor housing causing a circumferential groove in the housing. Maintenance records indicated the PTG had been removed twice to accommodate other maintenance. Also, the PTG was overhauled in July 1995. During that 46-month period of time, the PTG acquired 1,592 hours of operating time.

The submitter suggested that personnel pay close attention to detail when installing these units.

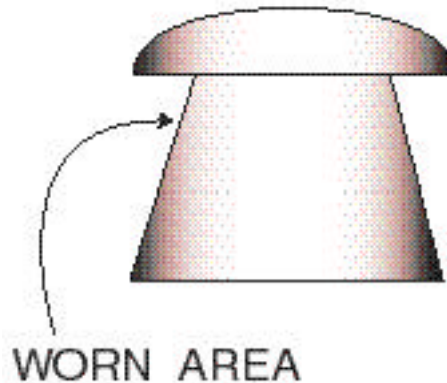
Teledyne Continental; Model A65; Piston Pin Plug Wear; ATA8520

The technician removed the cylinders and discovered abnormal piston pin plug wear was the source of these metal particles. All of the piston pin plugs (P/N 25117) were worn beyond serviceable limits and the wear pattern formed a "taper." (Refer to the following illustration.) A piston pin plug from the

number 1 cylinder was worn .095 inch, and the remaining plugs were worn between .005 and .01 inch.

All of the piston pins and plugs were new at the time of overhaul, and the submitter could not determine a cause for this defect.
